Mystery Markings

Arguably one of the least known-about tactical markings ever employed on Luftwaffe aircraft - Paul Lucas looks at the 'bar' markings employed on Kampflieger bombers during the period September - November 1940, in the Battle of Britain

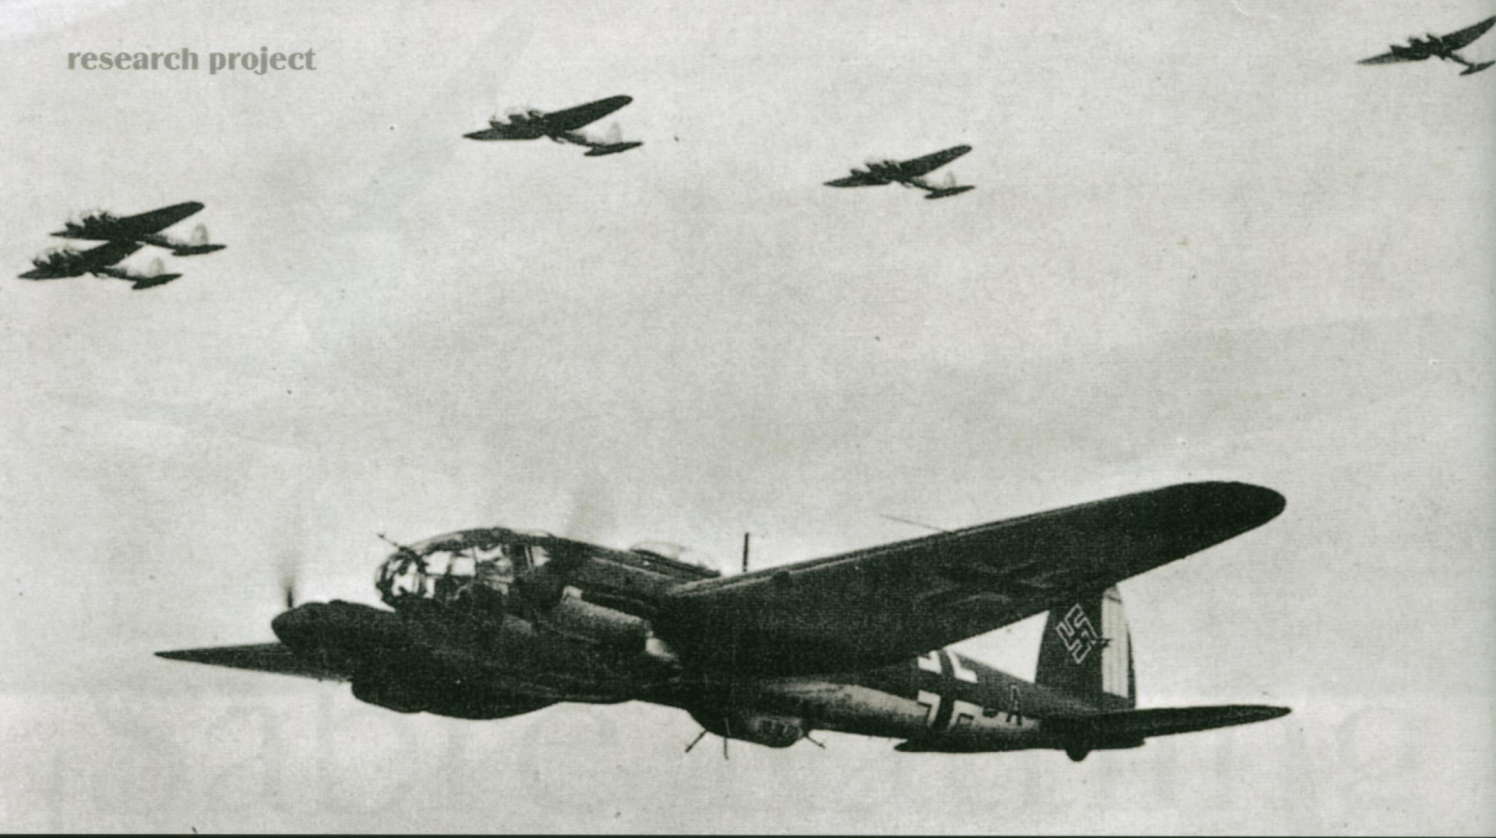
ABOVE Formation of He 111H-2s of KG 53 on their way to bomb London in September 1940. Note the three bars on the rudder of the aircraft nearest the camera.

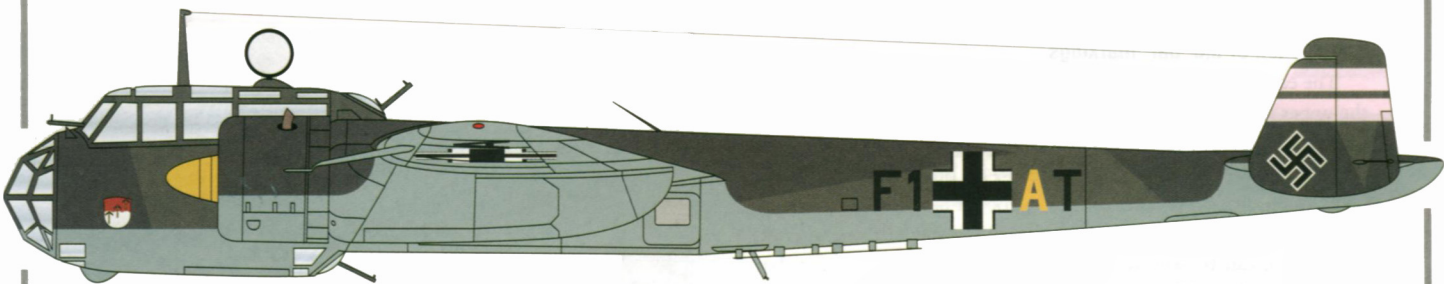
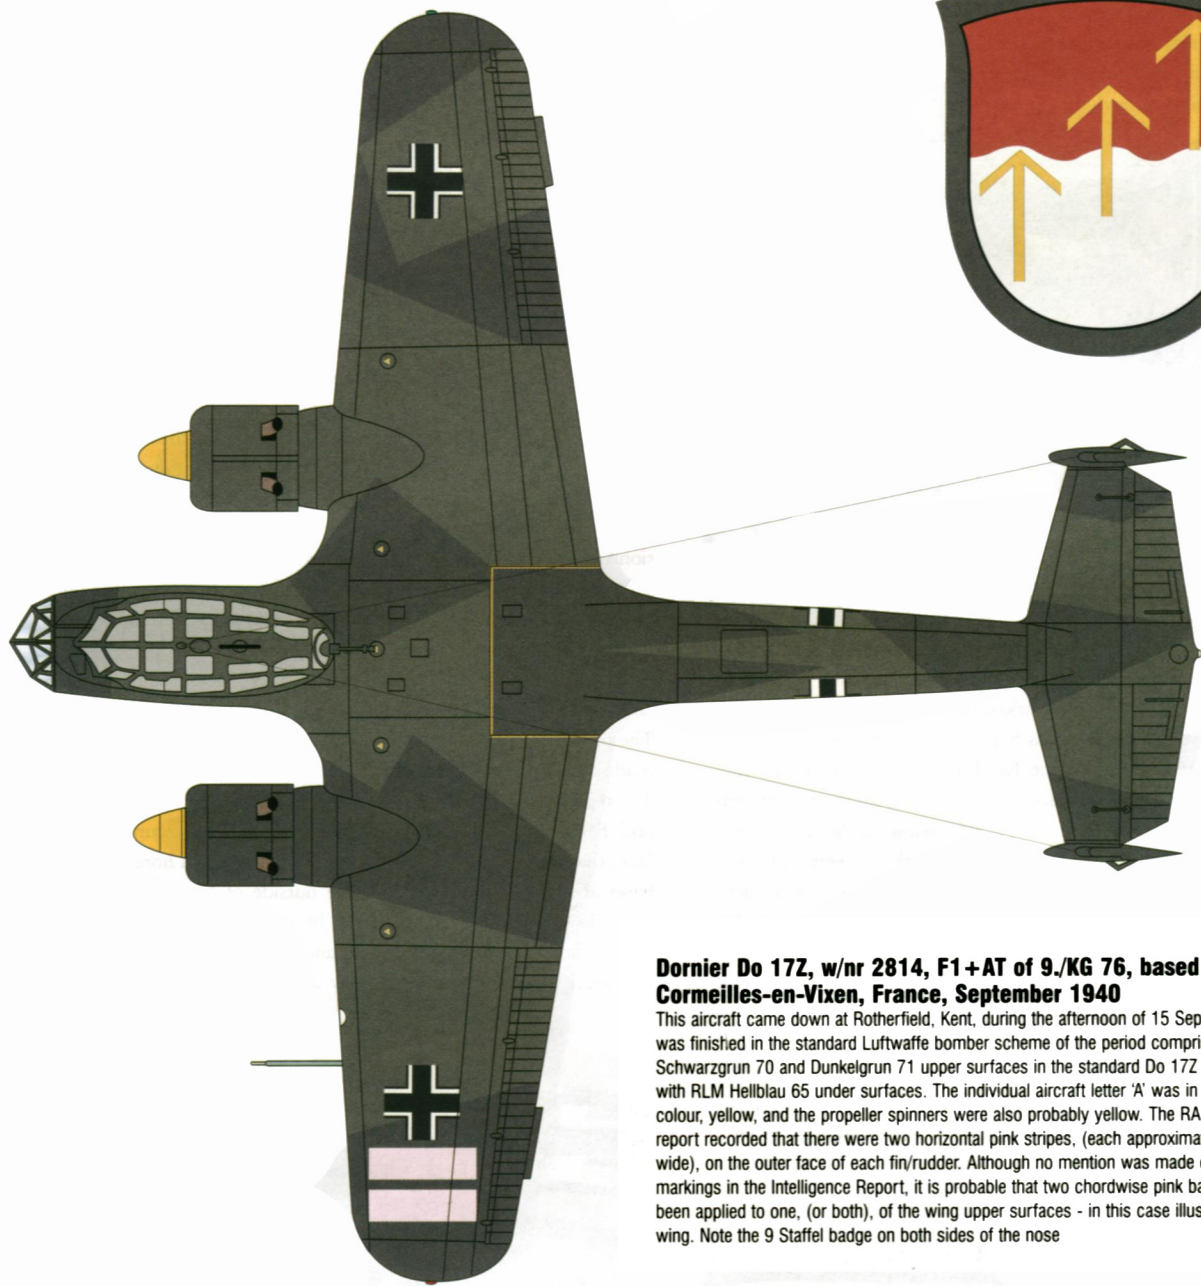
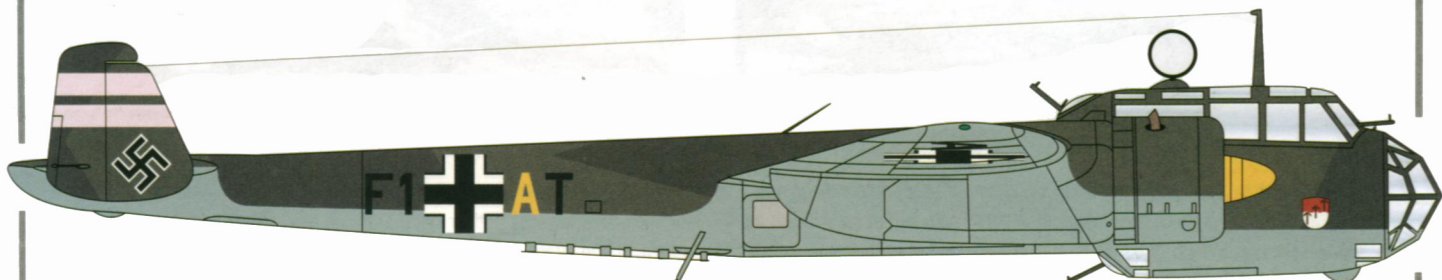
Dornier Do 17Z, w/nr 2814, F1+AT of 9./KG 76, based at Cormeilles-en-Vixen, France, September 1940

This aircraft came down at Rotherfield, Kent, during the afternoon of 15 September 1940. It was finished in the standard Luftwaffe bomber scheme of the period comprising RLM Schwarzgrun 70 and Dunkelgrun 71 upper surfaces in the standard Do 17Z splinter pattern with RLM Hellblau 65 under surfaces. The individual aircraft letter 'A' was in the 9 Staffel colour, yellow, and the propeller spinners were also probably yellow. The RAF Intelligence report recorded that there were two horizontal pink stripes, (each approximately 12 inches wide), on the outer face of each fin/rudder. Although no mention was made of any wing markings in the Intelligence Report, it is probable that two chordwise pink bars may have been applied to one, (or both), of the wing upper surfaces - in this case illustrated on the port wing. Note the 9 Staffel badge on both sides of the nose

Do 17Z WNr 2814, F1+AT of 9./KG 76, which came down at Rotherfield, Kent during the afternoon of 15 September 1940, and was found to have two horizontal pink stripes, each 12 inches wide on each rudder. No mention is made of any wing markings.

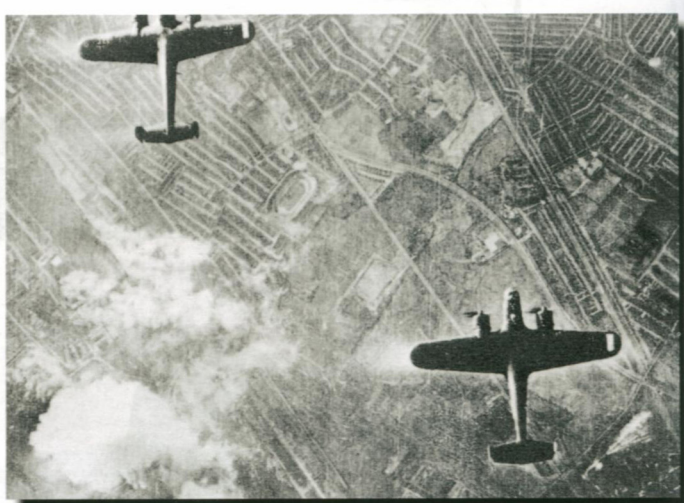
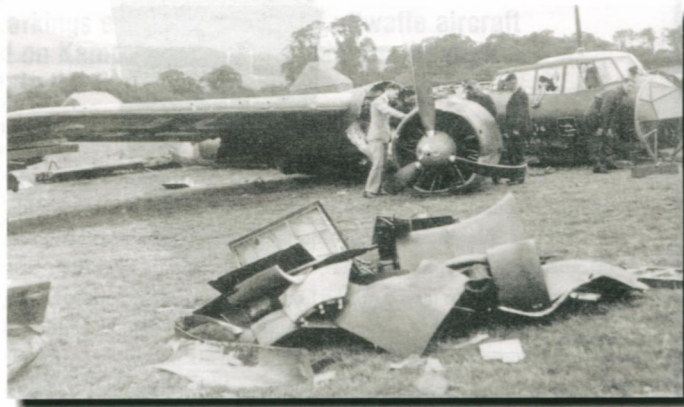
TOP Two photos of a pair of Dornier Do 17Zs, purportedly photographed on 7 September 1940, flying over London Docks heading for Woolwich Arsenal. Note that both aircraft have 'light coloured chordwise bars', outboard of the national markings on the upper surfaces of their starboard wing tips. **ABOVE** Two photos of Dornier Do 17Z, F1+FS of 8./KG 76, which force landed at Lullington Castle, Shoreham, on the afternoon of 15 September 1940. The RAF Intelligence report recorded that the aircraft had red spinners, a red band around the fuselage and that there was a horizontal pink band about 12 inches wide on the outside of both rudders. In the left hand photo note the chordwise bar just inboard of the national marking on the upper surface of the port wing.

The earliest recorded use of these markings which were applied to the upper surfaces of the wings and sides of the fin and/or rudder, is in a photograph of two Do 17s of KG 76, reputedly taken over London during the evening of 7 September 1940. Both the aircraft in the photograph display a chordwise bar outboard of the national marking on the upper surface of the starboard wing whilst one aircraft, (coded 'G'), can be seen to be also carrying a single horizontal bar across the starboard fin and rudder.

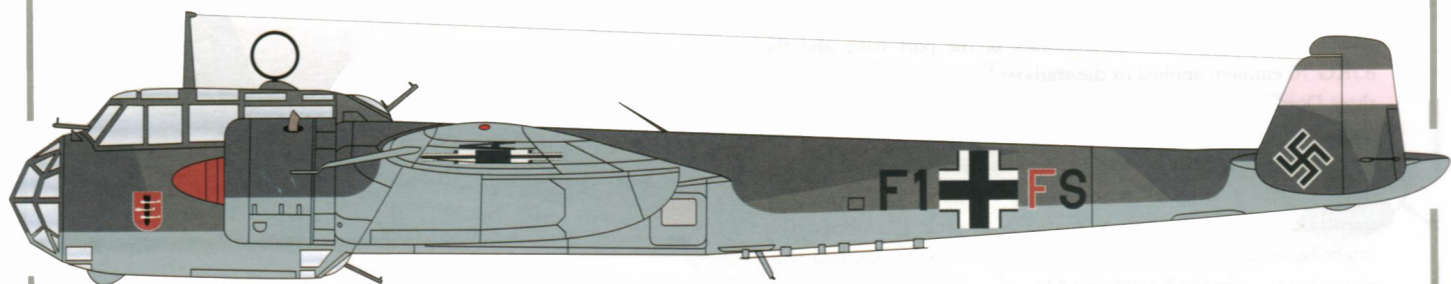
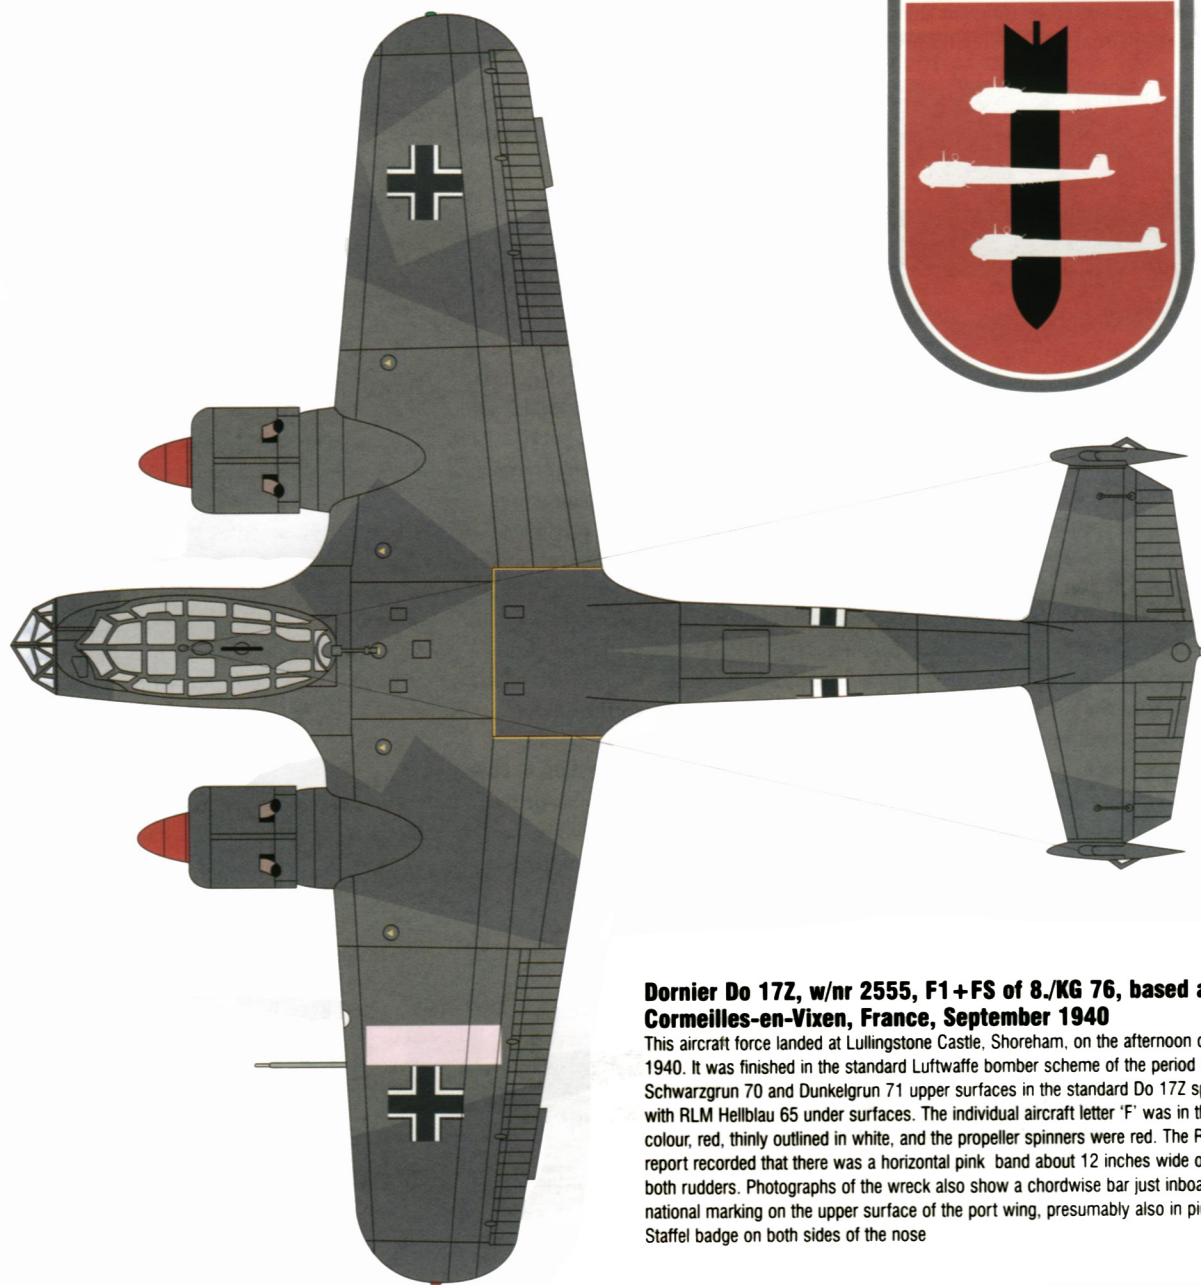
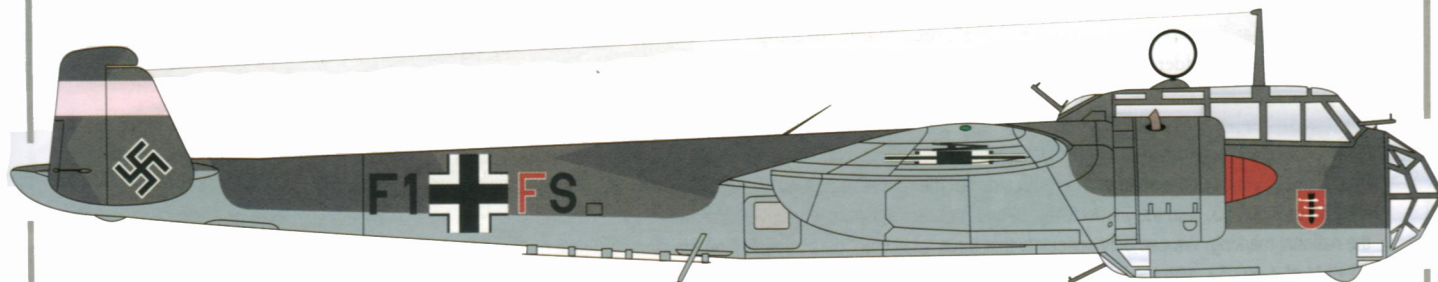
Dornier Do 17Z, w/nr 2555, F1 +FS of 8./KG 76, based at Corneilles-en-Vixen, France, September 1940

This aircraft force landed at Lullingstone Castle, Shoreham, on the afternoon of 15 September 1940. It was finished in the standard Luftwaffe bomber scheme of the period comprising RLM Schwarzgrun 70 and Dunkelgrun 71 upper surfaces in the standard Do 17Z splinter pattern with RLM Hellblau 65 under surfaces. The individual aircraft letter 'F' was in the 8 Staffel colour, red, thinly outlined in white, and the propeller spinners were red. The RAF Intelligence report recorded that there was a horizontal pink band about 12 inches wide on the outside of both rudders. Photographs of the wreck also show a chordwise bar just inboard of the national marking on the upper surface of the port wing, presumably also in pink. Note the 8 Staffel badge on both sides of the nose

For example, two Do 17Zs of KG 76 which were lost on the afternoon of 15 September, were the subjects of RAF Intelligence reports. The first was Werknummer 2555, coded F1+FS of 8./KG 76 which made a forced landing at Lullington Castle, Shoreham, at 1300hrs. The report recorded that the aircraft was coded F1+FS with the second 'F' outlined in white; that there was a red band around the fuselage; that the spinners were red, and that there was a horizontal pink band about 12 inches wide on the outside of both rudders. Photographs of the wreck indicate that by using the term 'rudders' the report's author actually meant 'fin and rudder'. The photographs of the wreck of this aircraft also show a chordwise bar inboard of the

national marking on the upper surface of the port wing and the 8./KG 76 emblem applied to the starboard side of the nose with the three Dornier profiles thereon pointing forward, although neither of these markings are mentioned in the report.

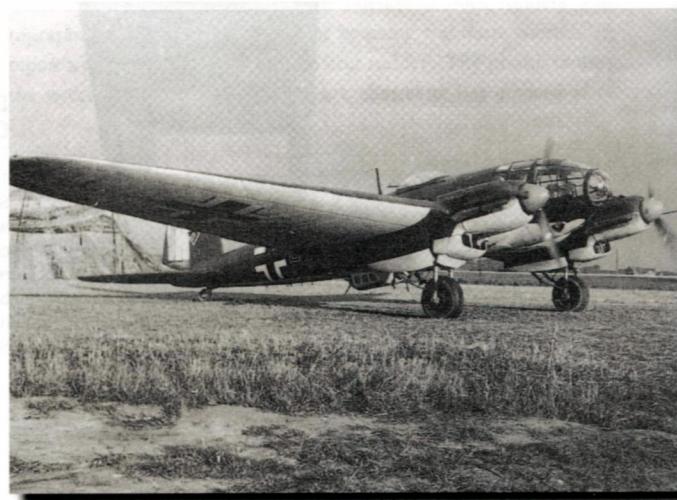
TOP He 111H-2, coded A1+BA of the Geschwaderstab KG 53, (with the 'Staffel' letter 'A' outlined in blue), and three vertical, 'light coloured' bars, on the rudder. Again, whether these bars appeared on both sides of the rudder or any wing markings were carried is unfortunately not known. **MIDDLE** He 111H-2, coded A1+BT of 9./KG 53, with the Staffel letter 'B' and propeller spinners in yellow. Three large 'light coloured' bars can be seen on the starboard wing, just inboard of the national marking. We can only speculate that three 'matching' bars appeared on the starboard side of the rudder. **BOTTOM** He 111H-1, probably coded A1+LM of 4./KG 53, with the individual aircraft letter 'L' outlined in white. Note the three vertical pink (?) bars on the rudder. Whether these bars appeared on both sides of the rudder or whether any wing markings were carried is not known.

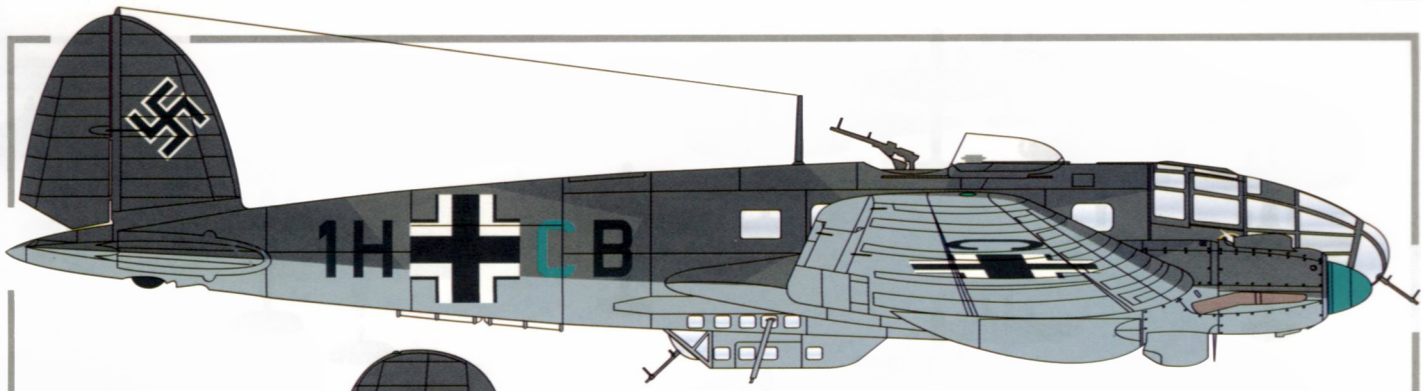
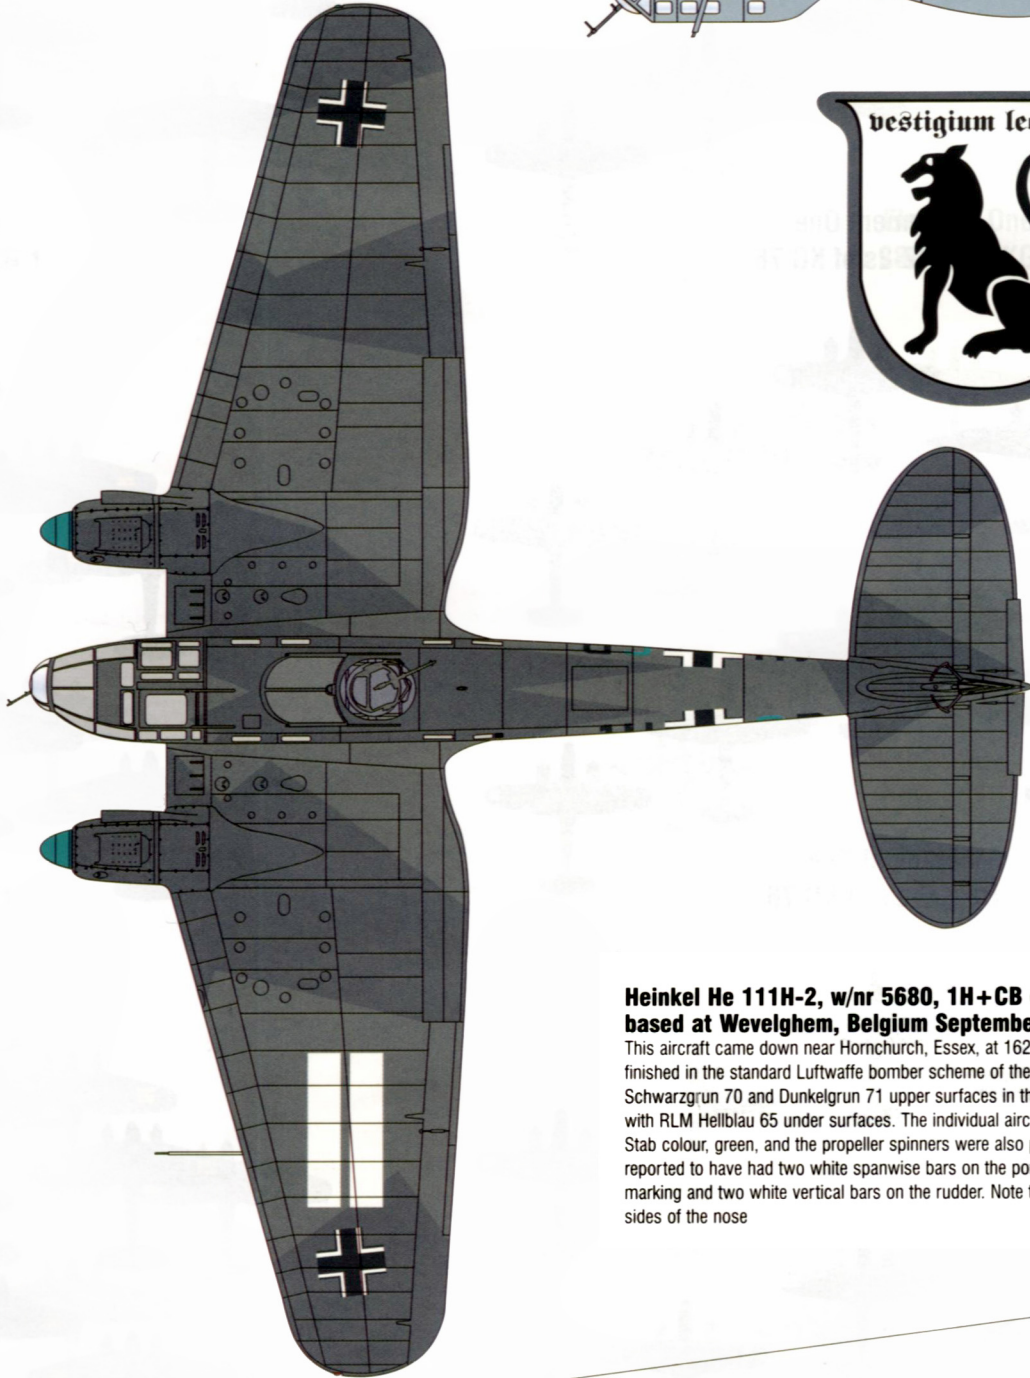
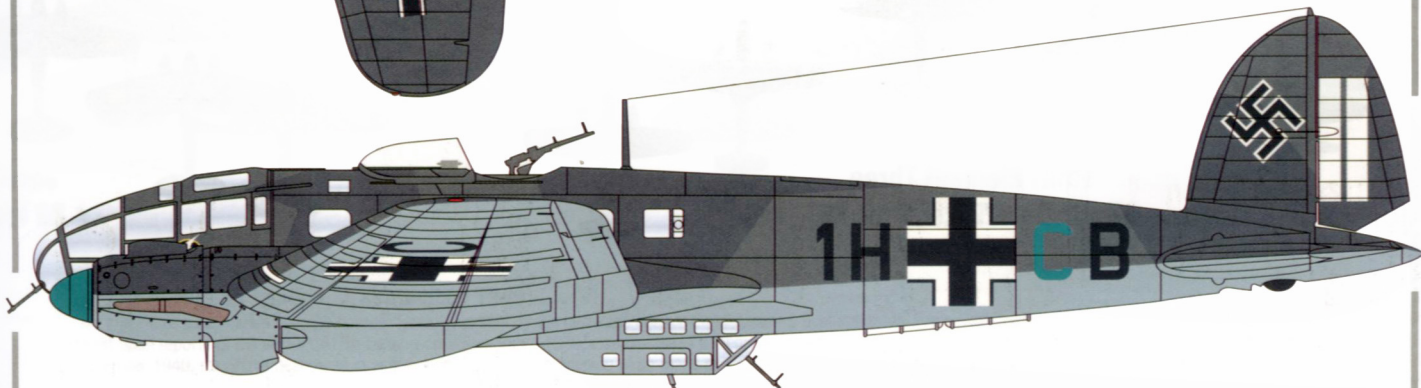
Heinkel He 111H-2, w/nr 5680, 1H+CB of I Gruppe Stab/KG 26, based at Wevelghem, Belgium September 1940

This aircraft came down near Hornchurch, Essex, at 1620hrs on 11 September 1940. It was finished in the standard Luftwaffe bomber scheme of the period comprising RLM Schwarzgrun 70 and Dunkelgrun 71 upper surfaces in the standard He 111H splinter pattern with RLM Hellblau 65 under surfaces. The individual aircraft letter 'C' was in the I Gruppe Stab colour, green, and the propeller spinners were also probably green. This aircraft was reported to have had two white spanwise bars on the port wingtip, inboard of the national marking and two white vertical bars on the rudder. Note the I Gruppe KG 26 badge on both sides of the nose

White was also said to have been found on the remains of a He 111H-3, WNr 5680, coded 1H+CB of Stab I/KG 26, which came down near Hornchurch at 1620hrs on 11 September 1940. This aircraft is said to have had two white stripes on the port wingtip and the rudder.

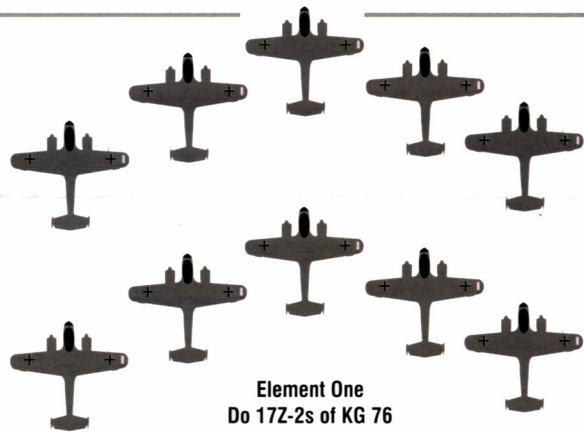
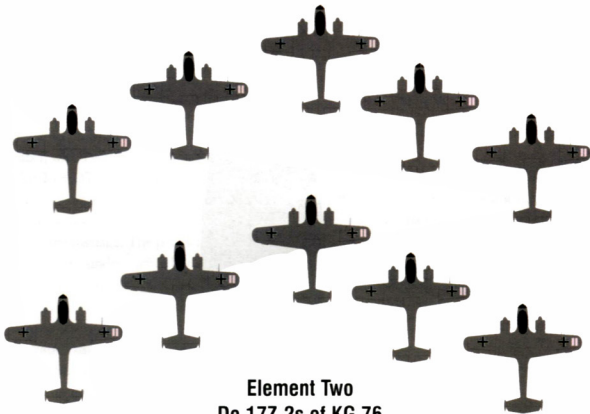
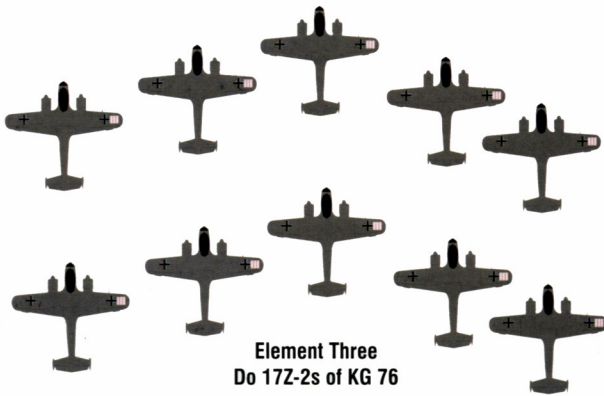
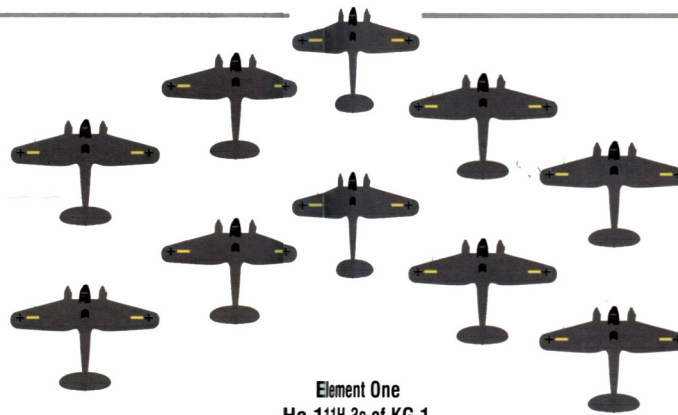
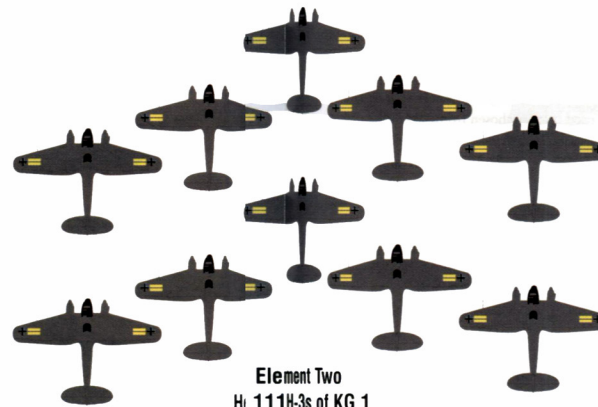
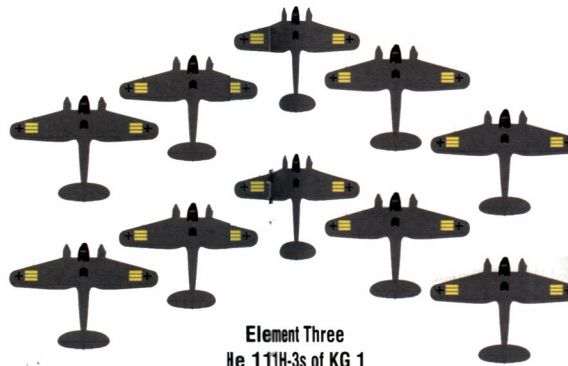
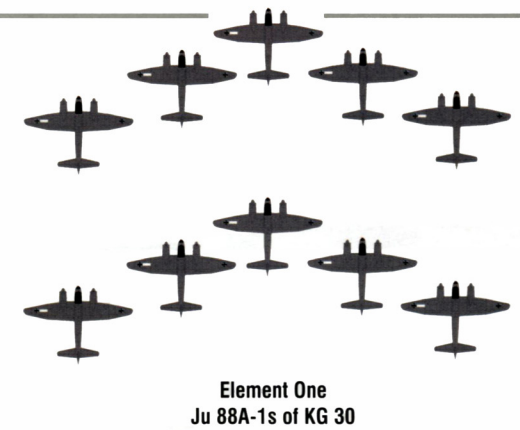
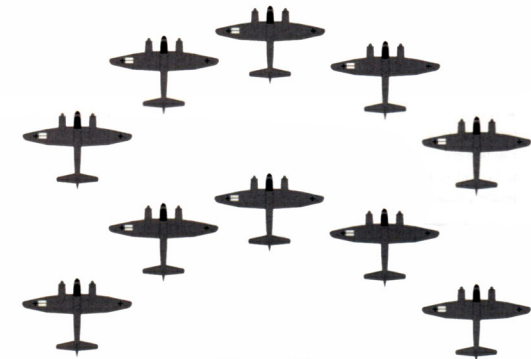
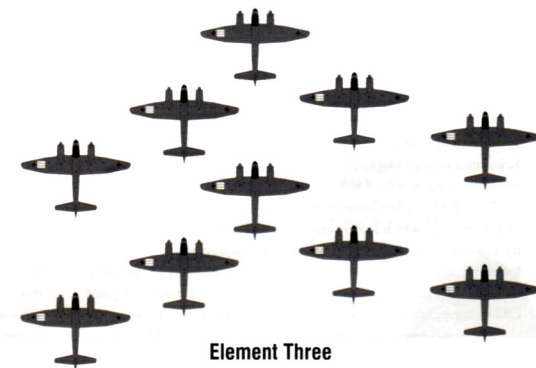
Luftwaffe raid on London, 7 September 1940

This schematic view shows how the bomber formations sent by the Luftwaffe against London during September 1940 may have looked. This, admittedly speculative, illustration, based upon reports of the actual raid on London on 7 September 1940, also illustrates a theory of how the 'mysterious bar markings' applied to so many Luftwaffe bombers during September 1940, may have been used in assisting in the formation keeping of so many aircraft from many different units and bases

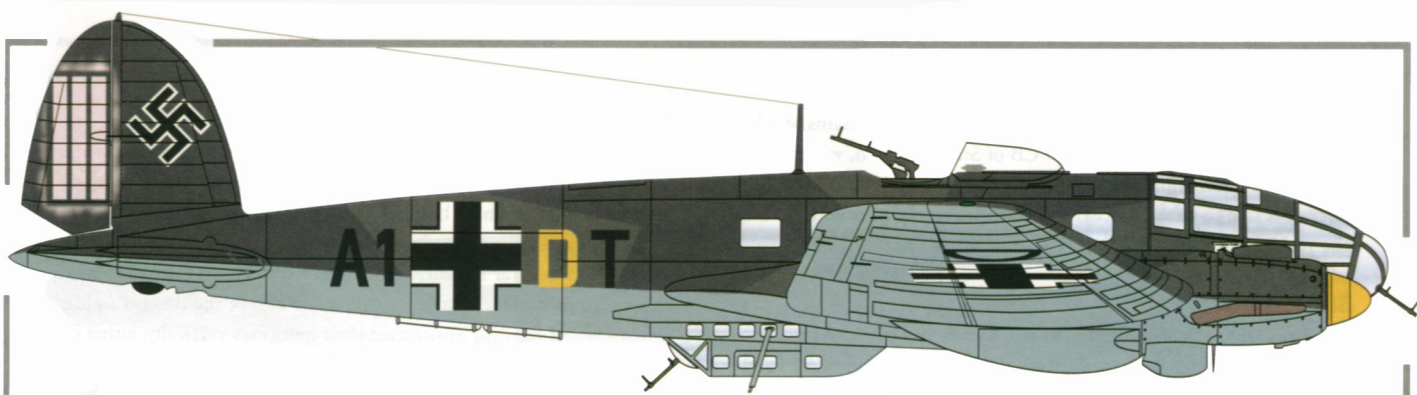
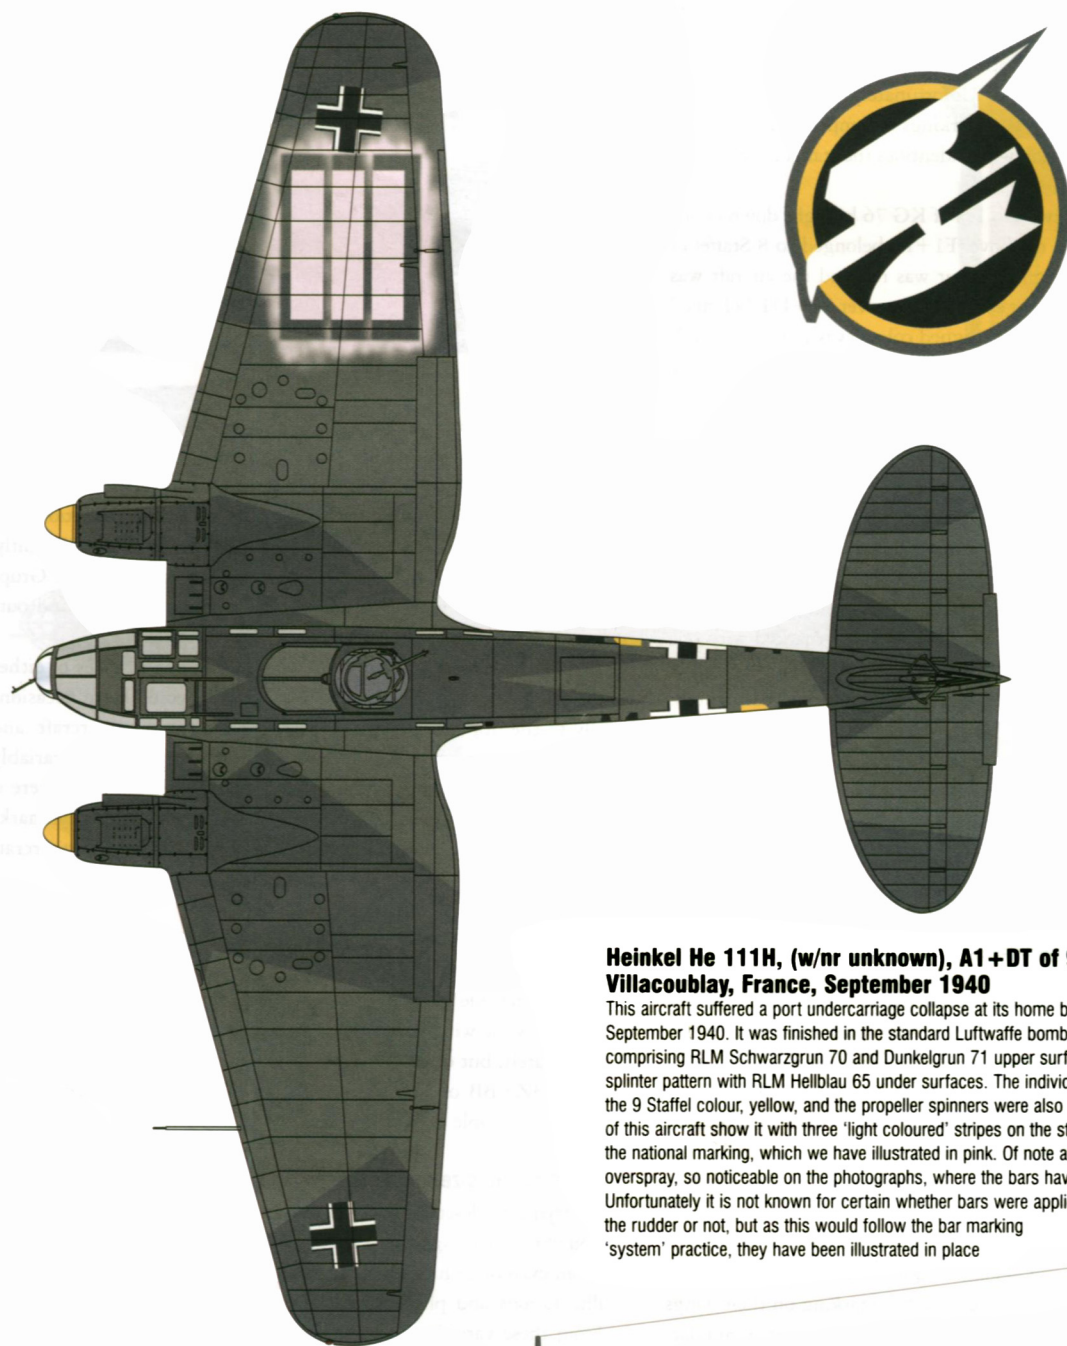
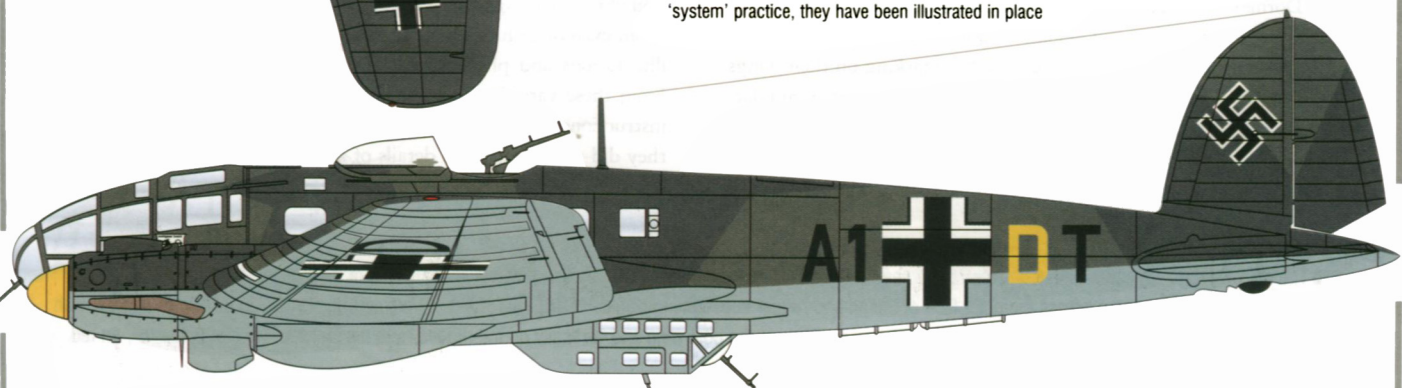
Heinkel He 111H, (w/nr unknown), A1+DT of 9./KG 53, based at Villacoublay, France, September 1940

TOP He 111H-2, coded A1+DT of 9./KG 53, with three 'light coloured' stripes on the starboard wing, just inboard of the national marking. Note the areas of overspray where the bars have been masked out. Unfortunately, as the rudder is slightly offset to the right, it is impossible to tell whether bars were applied on the starboard side of the rudder or not. **BOTTOM** Despite its relatively poor quality, this photograph of a Kette of He 111Hs, (unit unknown), is one of the very few photographs showing bars on *both* wing tips - inboard of the national markings. Unfortunately the shadow cast across the fins and rudders has made it impossible to tell whether bars were carried or not.

This aircraft suffered a port undercarriage collapse at its home base of Villacoublay, France in September 1940. It was finished in the standard Luftwaffe bomber scheme of the period comprising RLM Schwarzgrun 70 and Dunkelgrun 71 upper surfaces in the standard He 111H splinter pattern with RLM Hellblau 65 under surfaces. The individual aircraft letter 'D' was in the 9 Staffel colour, yellow, and the propeller spinners were also probably yellow. Photographs of this aircraft show it with three 'light coloured' stripes on the starboard wing, just inboard of the national marking, which we have illustrated in pink. Of note are the large areas of overspray, so noticeable on the photographs, where the bars have been masked out. Unfortunately it is not known for certain whether bars were applied on the starboard side of the rudder or not, but as this would follow the bar marking 'system' practice, they have been illustrated in place

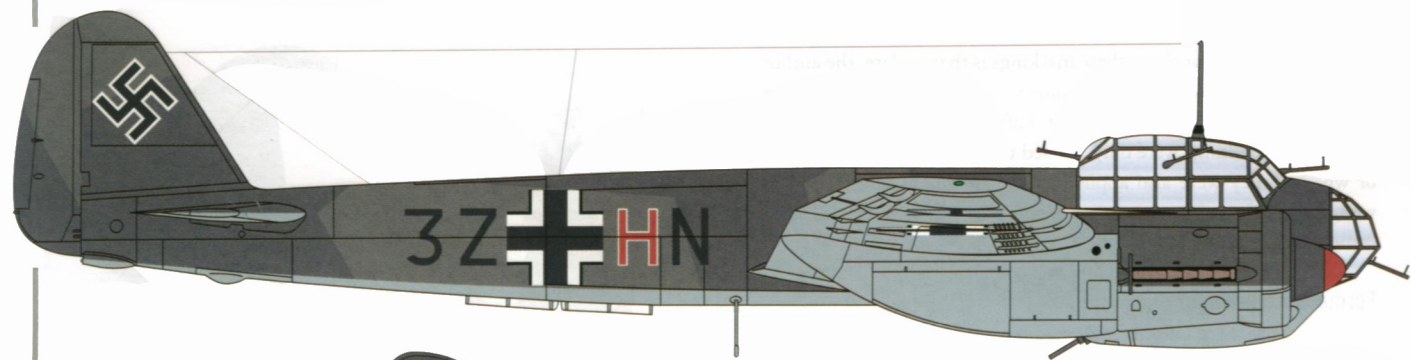
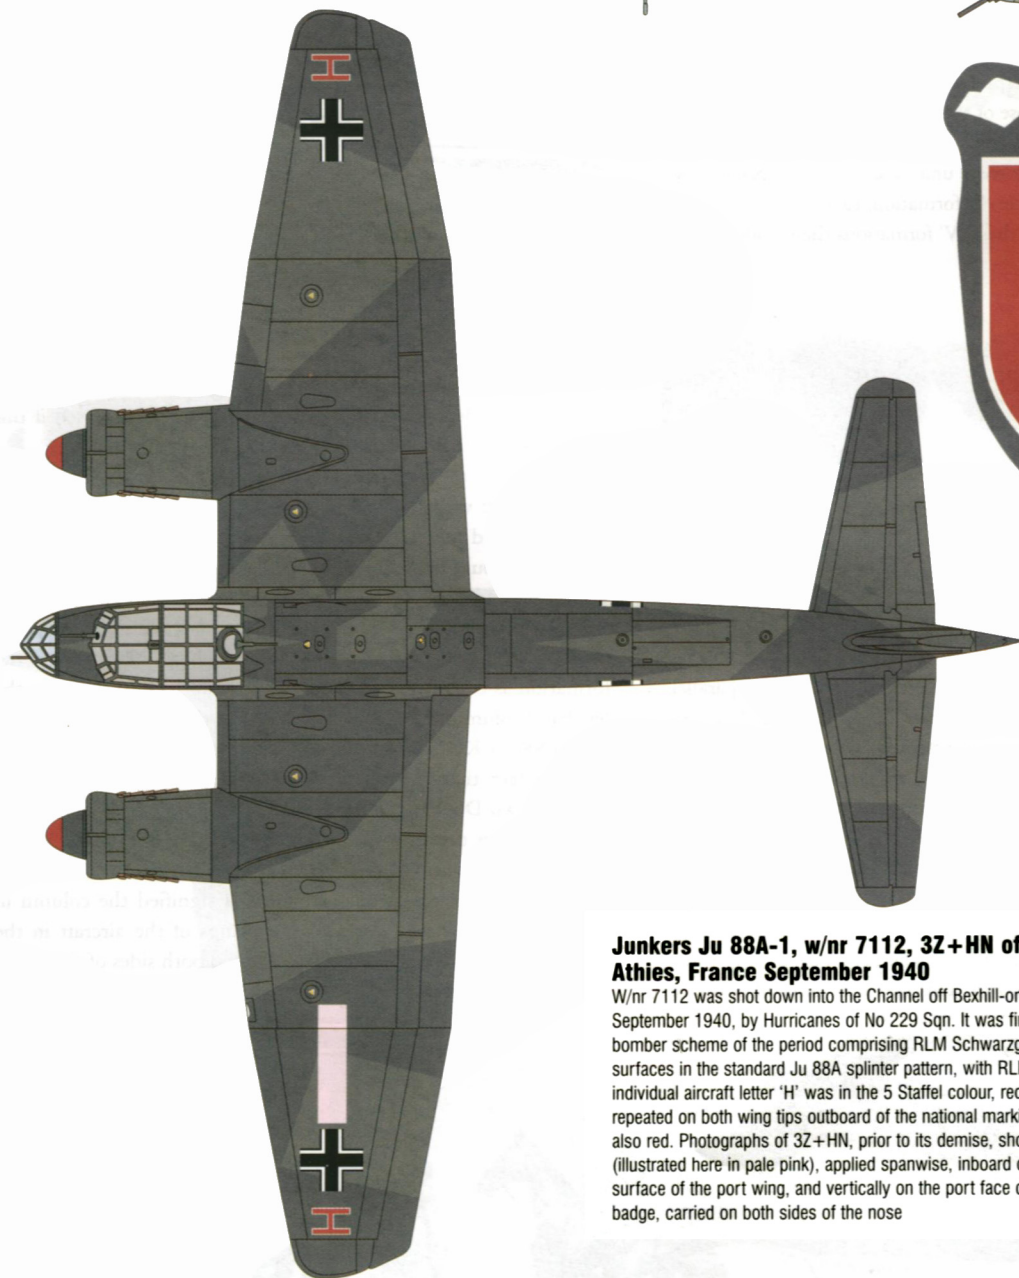
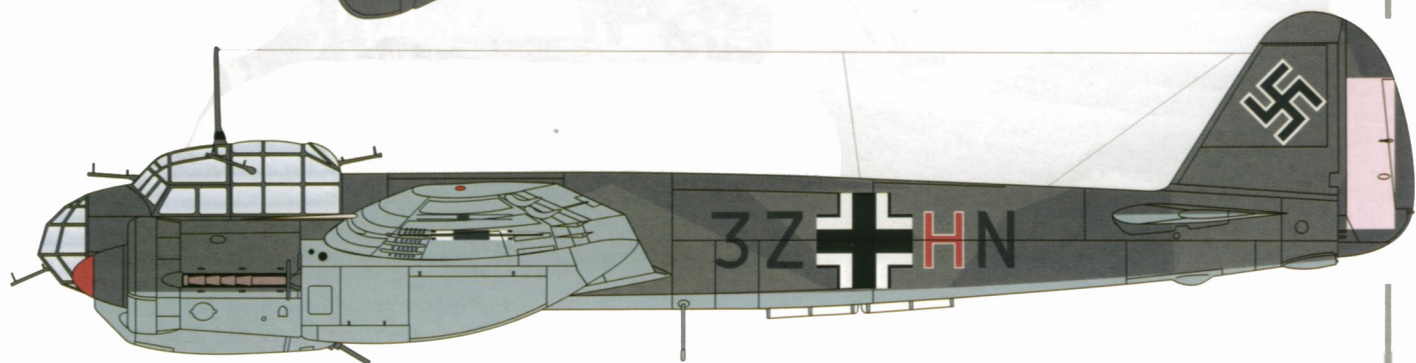
Junkers Ju 88A-1, w/nr 7112, 3Z+HN of 5./KG 77, based at Laon-Athies, France September 1940

W/nr 7112 was shot down into the Channel off Bexhill-on-Sea, Kent, on the afternoon of 27 September 1940, by Hurricanes of No 229 Sqn. It was finished in the standard Luftwaffe bomber scheme of the period comprising RLM Schwarzgrun 70 and Dunkelgrun 71 upper surfaces in the standard Ju 88A splinter pattern, with RLM Hellblau 65 under surfaces. The individual aircraft letter 'H' was in the 5 Staffel colour, red, thinly outlined in white, and repeated on both wing tips outboard of the national markings. The propeller spinners were also red. Photographs of 3Z+HN, prior to its demise, show it with a large light coloured bar, (illustrated here in pale pink), applied spanwise, inboard of the national marking on the upper surface of the port wing, and vertically on the port face of the rudder. Note the II/KG 77 badge, carried on both sides of the nose

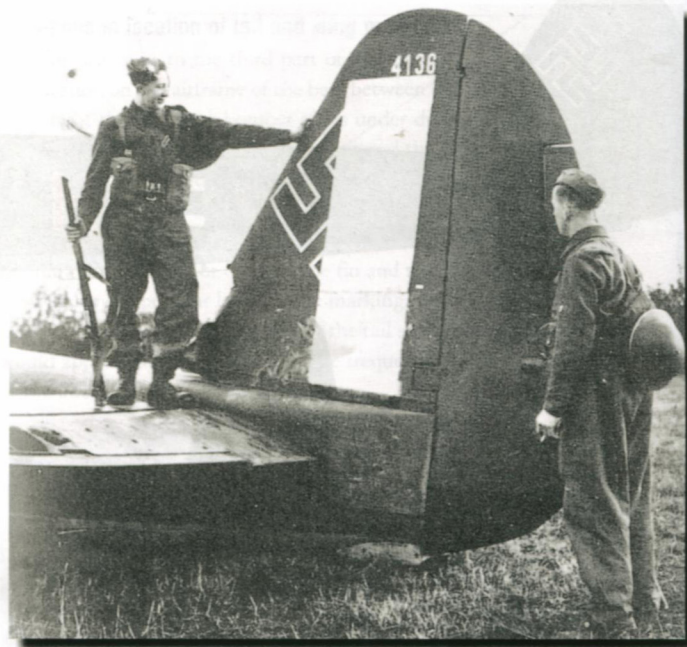
Quite how these markings worked has never really been satisfactorily explained either. Given the three suggested variations in their colour, the number of bars applied, and also their differing positions on the aircraft, the only interpretation seen by the author which attempts to explain the purpose of these markings, suggests that the number and positioning of the bars was related to the standard Luftwaffe bomber formation. The basic unit is said to have been some twenty or so aircraft in a double 'V' formation, each 'V' consisting of ten aircraft. Extended lines of these 'V' formations then made up the mass formation.

two column formation was the most common which would explain the lack of evidence for the third colour, yellow, being used if this colour was habitually assigned to the middle column.

Thus, when the formation as a whole was viewed from above and astern, aircraft with the markings applied to the port side would fly in the left hand column and aircraft which were marked on the starboard side would fly in the right hand column where the markings would be visible to each other and the aircraft in the middle column.

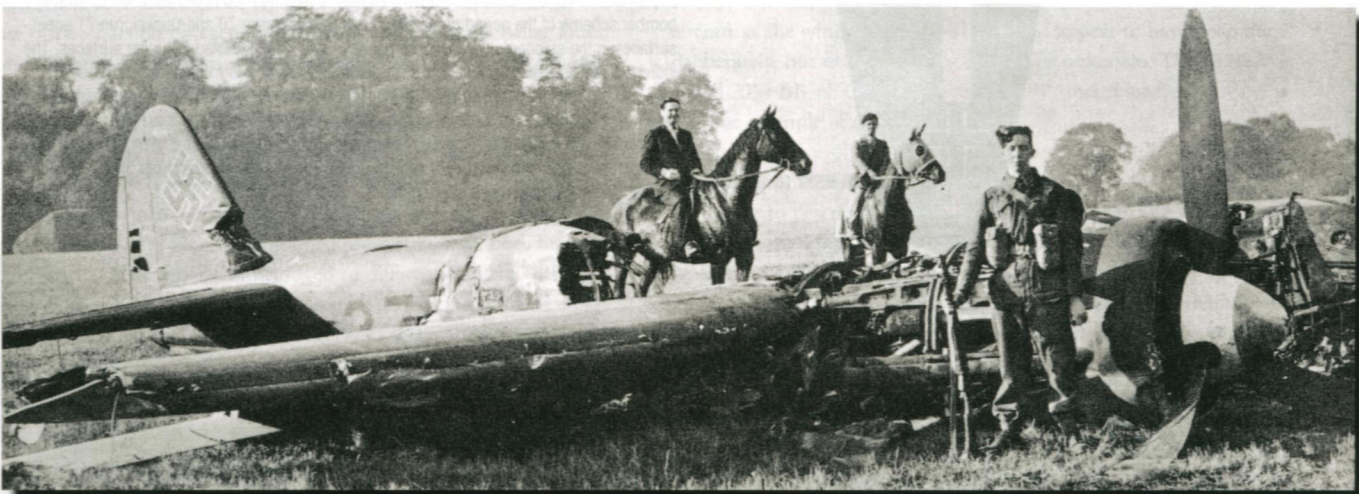
ABOVE Three views of Ju 88A-1, (Werksnummer 4136), 3Z+BB of I Gruppe Stab/KG 77, brought down at Hertingfordbury, Hertfordshire, on 3 October 1940. This aircraft had a large pale pink bar applied spanwise and outboard of the national marking on the port wing and vertically on the fin, obscuring part of the swastika!
