Mystery Markings

Arguably one of the least known-about tactical markings ever employed on Luftwaffe aircraft - Paul Lucas looks at the 'bar' markings employed on Kampflieger bombers during the period September - November 1940, in the Battle of Britain

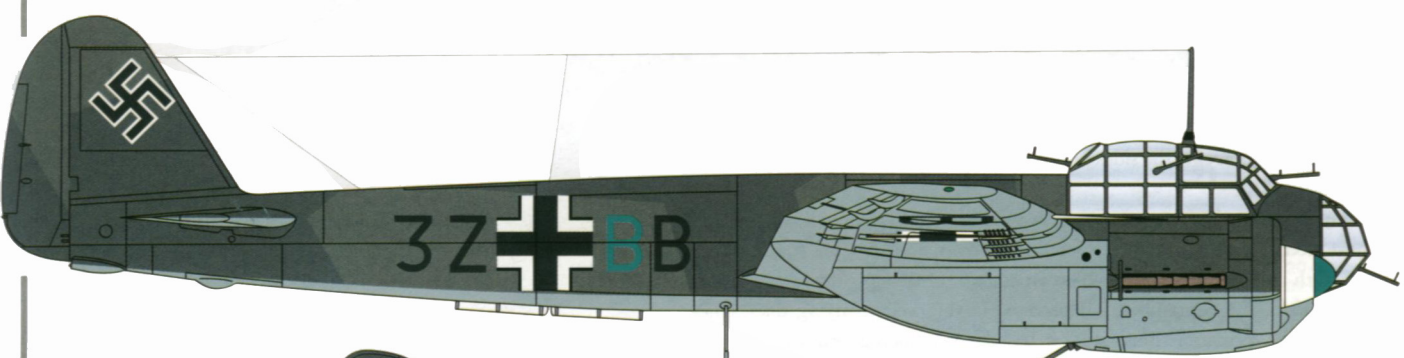
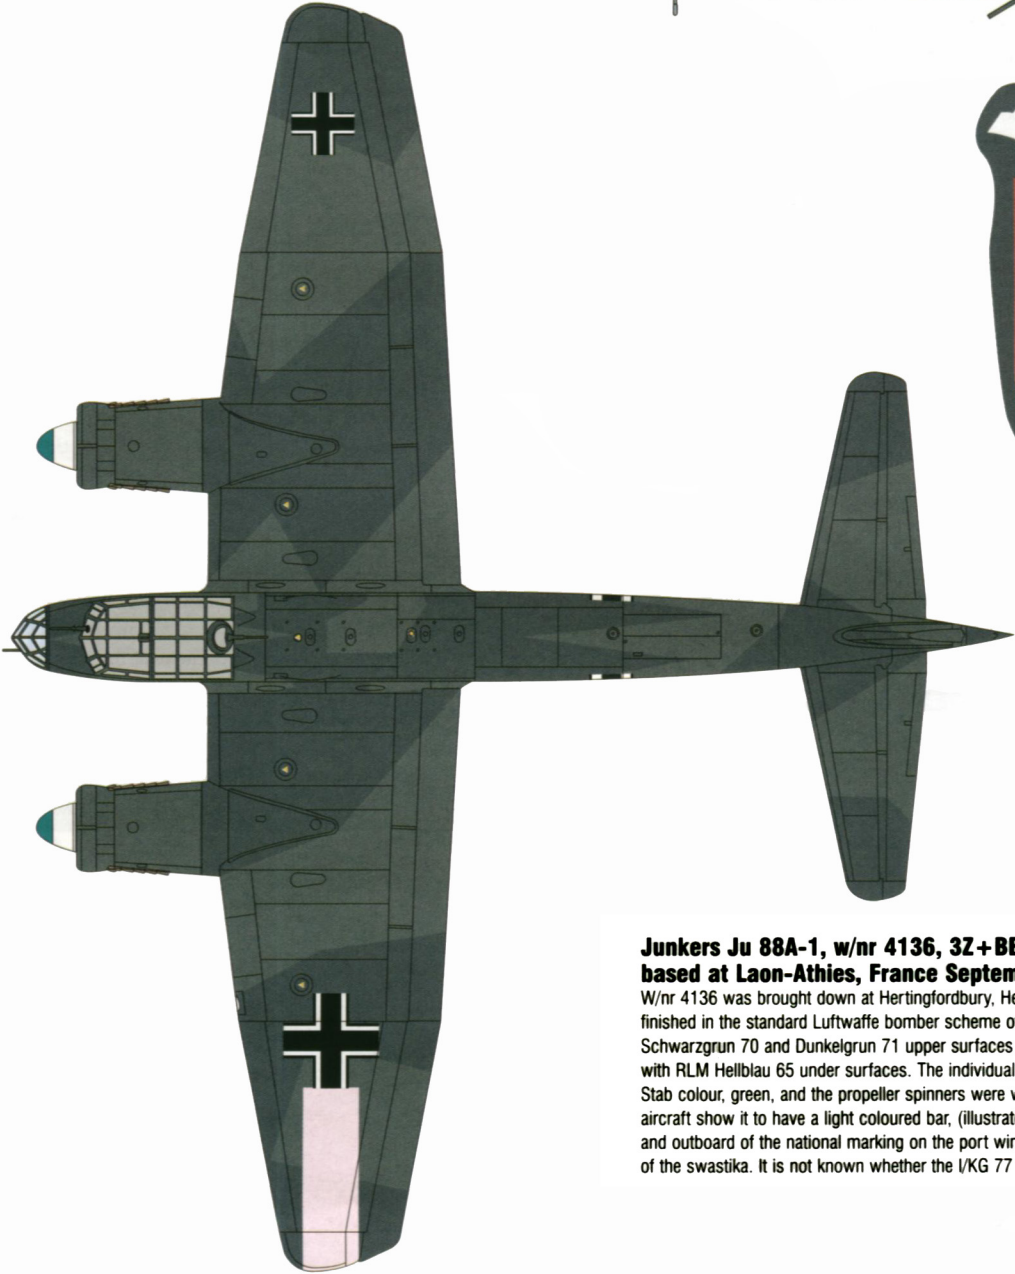
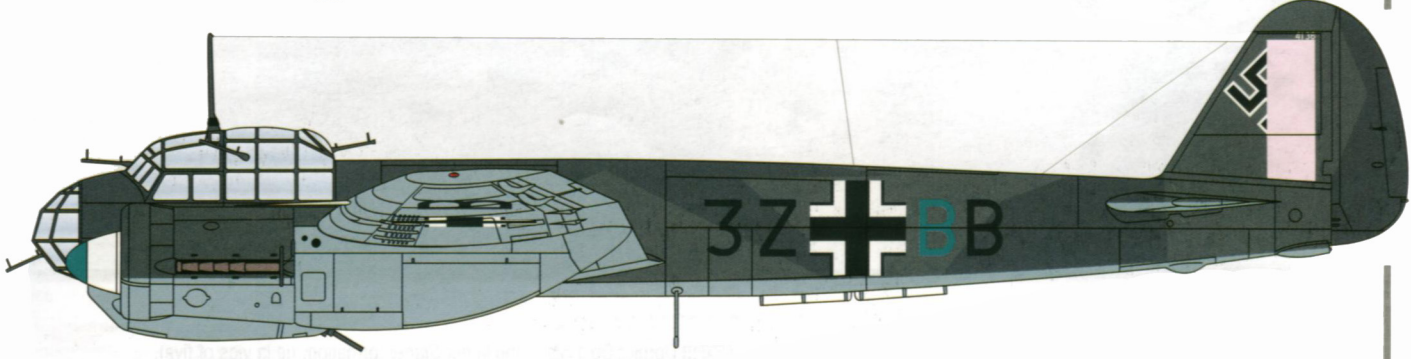
Junkers Ju 88A-1, w/nr 4136, 3Z+BB of I Gruppe Stab/KG 77, based at Laon-Athies, France September 1940

W/nr 4136 was brought down at Hertingfordbury, Hertfordshire, on 3 October 1940. It was finished in the standard Luftwaffe bomber scheme of the period comprising RLM Schwarzgrun 70 and Dunkelgrun 71 upper surfaces in the standard Ju 88A splinter pattern, with RLM Hellblau 65 under surfaces. The individual aircraft letter 'B' was in the I Gruppe Stab colour, green, and the propeller spinners were white with green tips. Photographs of this aircraft show it to have a light coloured bar, (illustrated here as pale pink), applied spanwise and outboard of the national marking on the port wing and vertically on the fin, obscuring part of the swastika. It is not known whether the I/KG 77 badge was carried on this aircraft

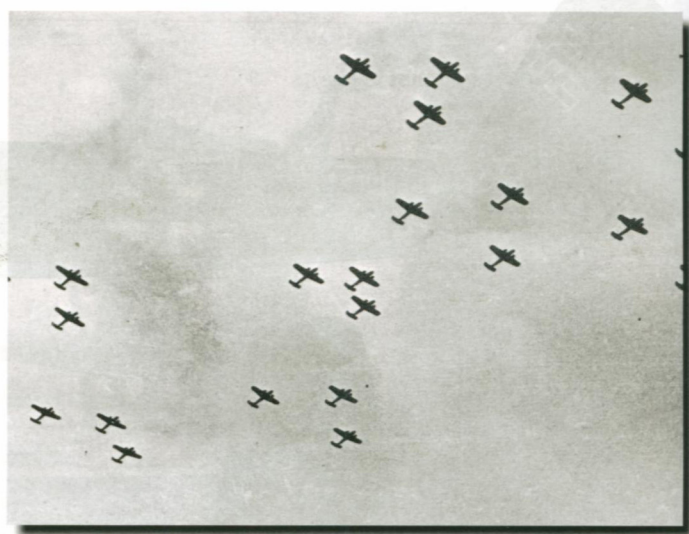
The markings would however appear to be very flexible and would allow for casualties inflicted on the Luftwaffe by the RAF and/or the inevitable periodic unserviceability for whatever reason, of an individual aircraft. The markings could be altered to allow each Geschwader to operate the maximum number of aircraft available or required for each sortie without having to adhere to a rigid system dictated by the Staffel or Gruppe to which the aircraft actually belonged.

Thus ultimately, the reason why a cohesive system cannot be identified might be because one does not exist, as the markings were

changed from one sortie to the next and the only way of pinning the system down would be to find some kind of record which would tell us which Geschwader flew how many aircraft in which column on a specific operation on a specific day.

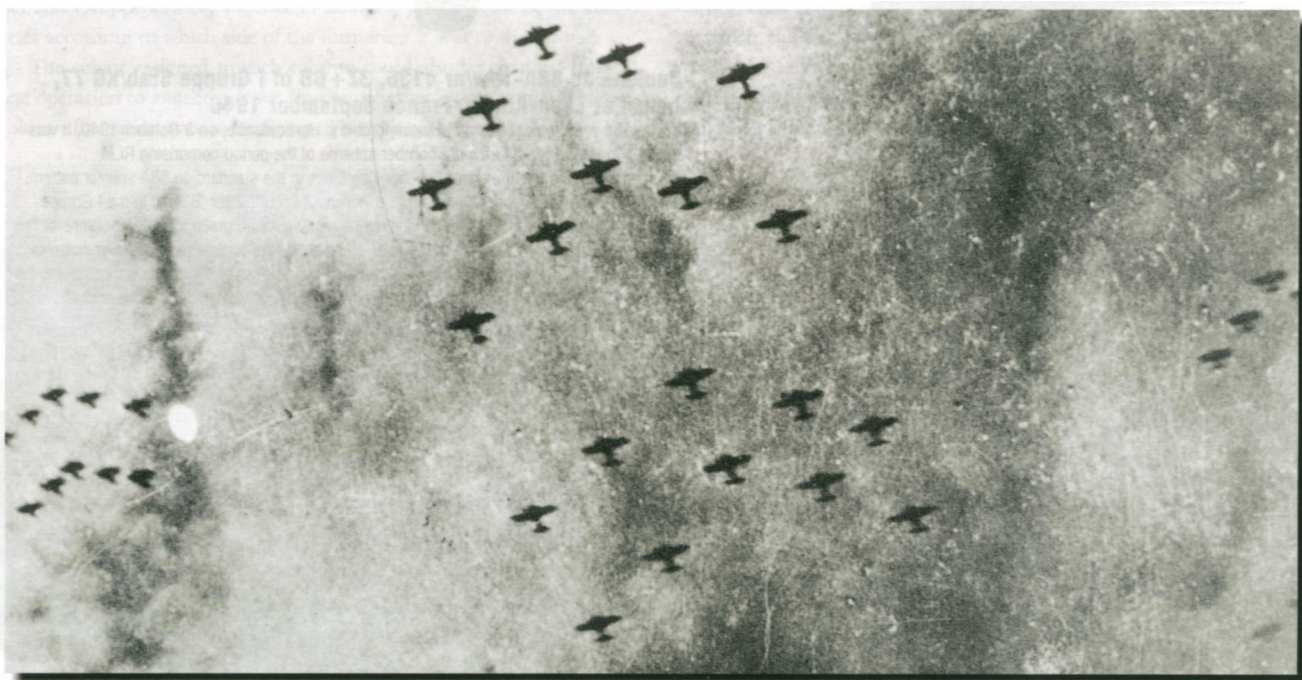
TOP Dornier Do 17Zs in the standard *Kette* formation, (ie in vics of three). **BOTTOM** Dornier Do 17Zs in the larger *Staffel* formation, (ie in vics of five).

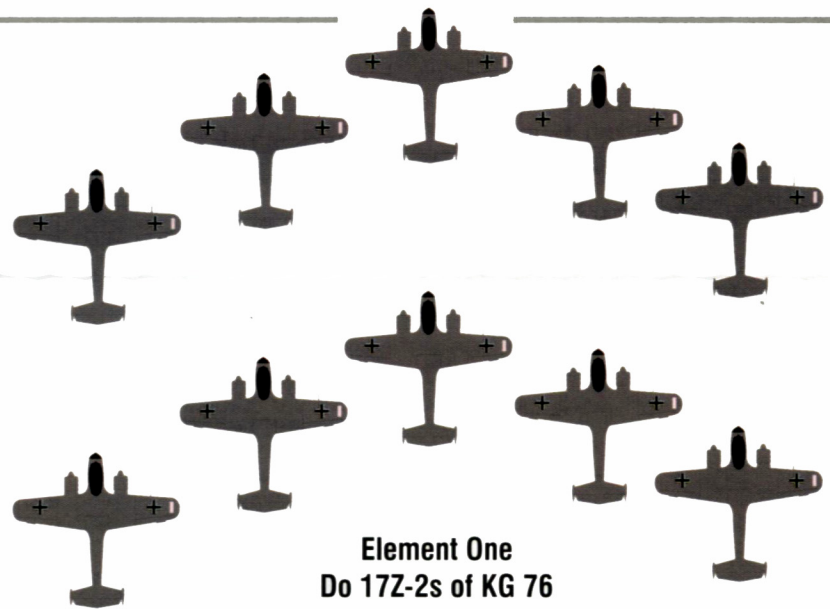
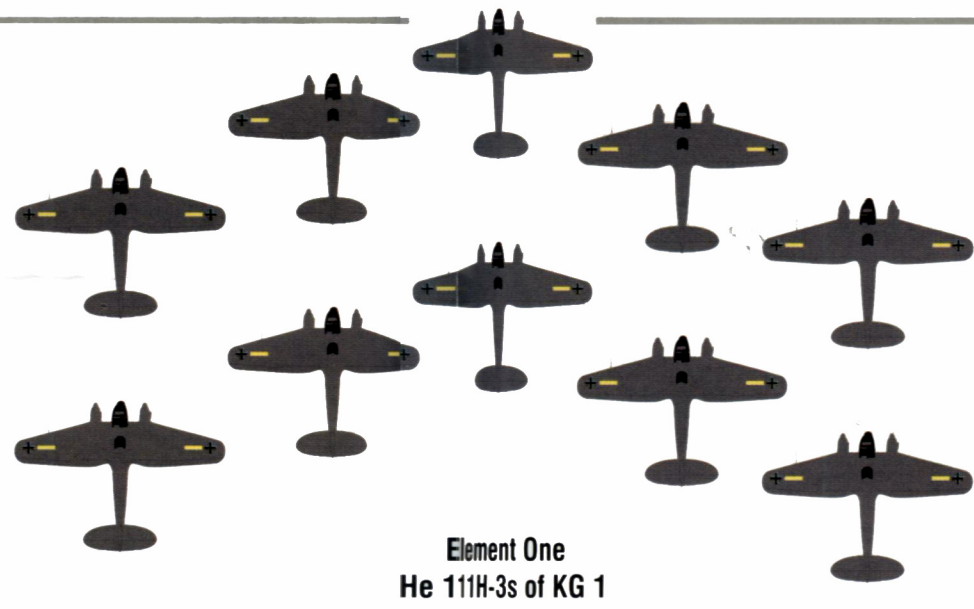
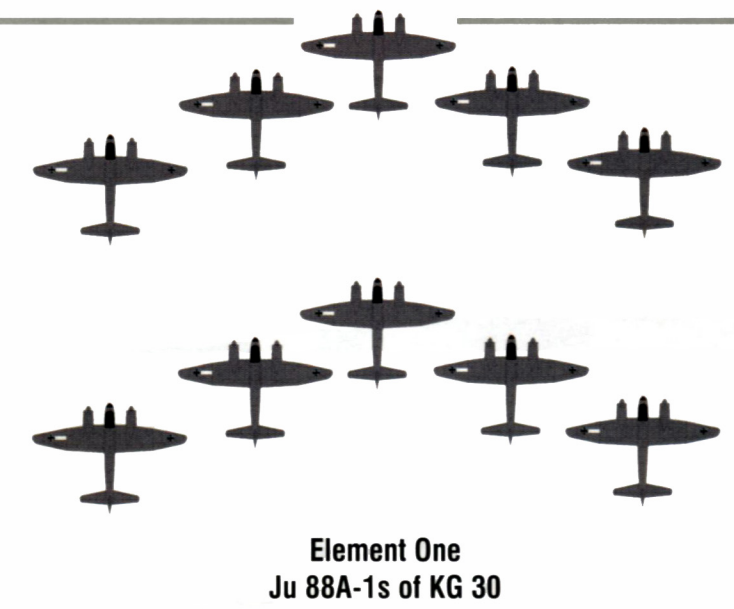
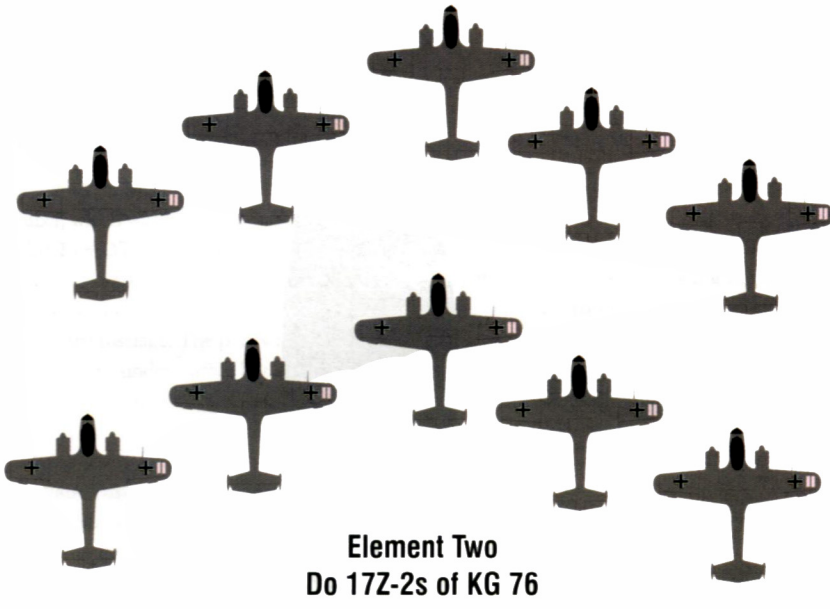
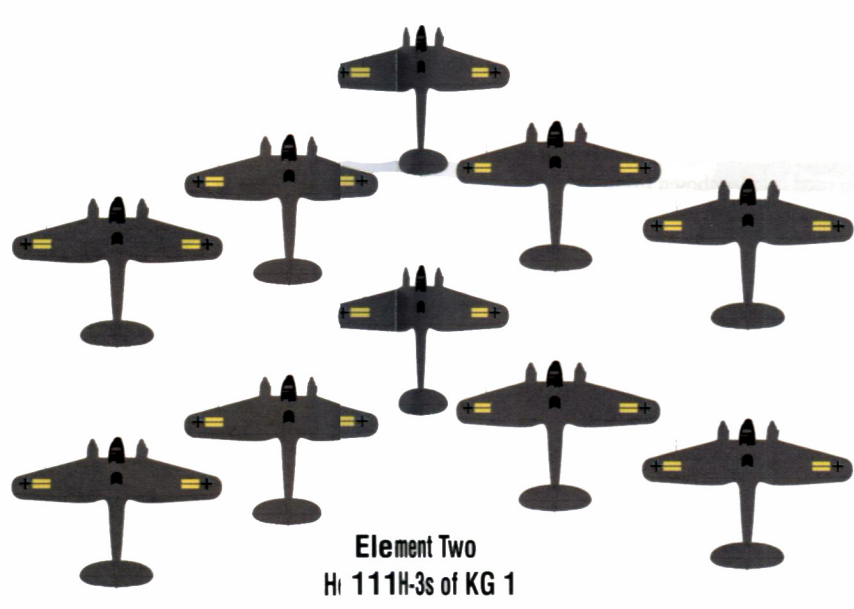
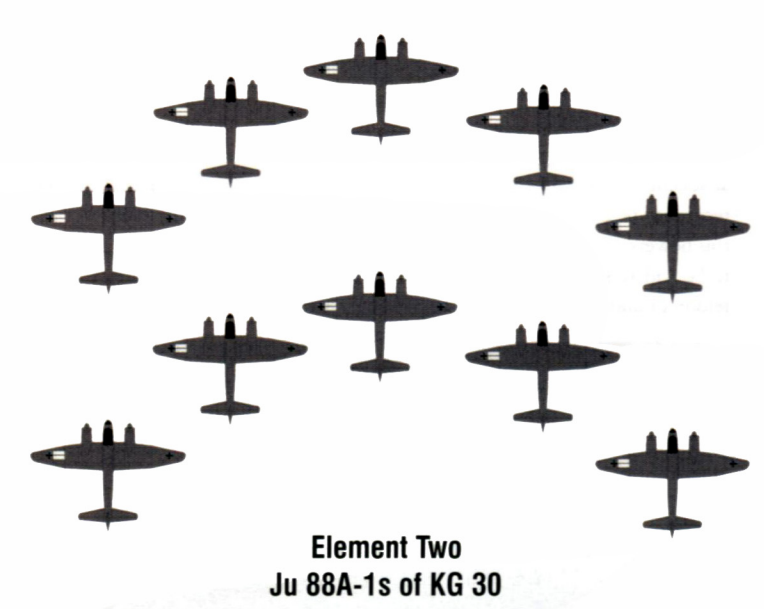
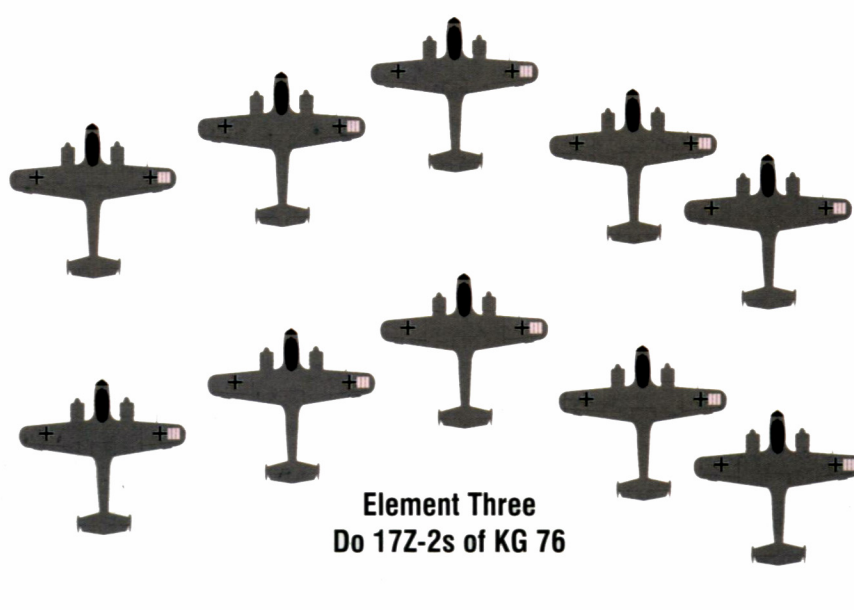
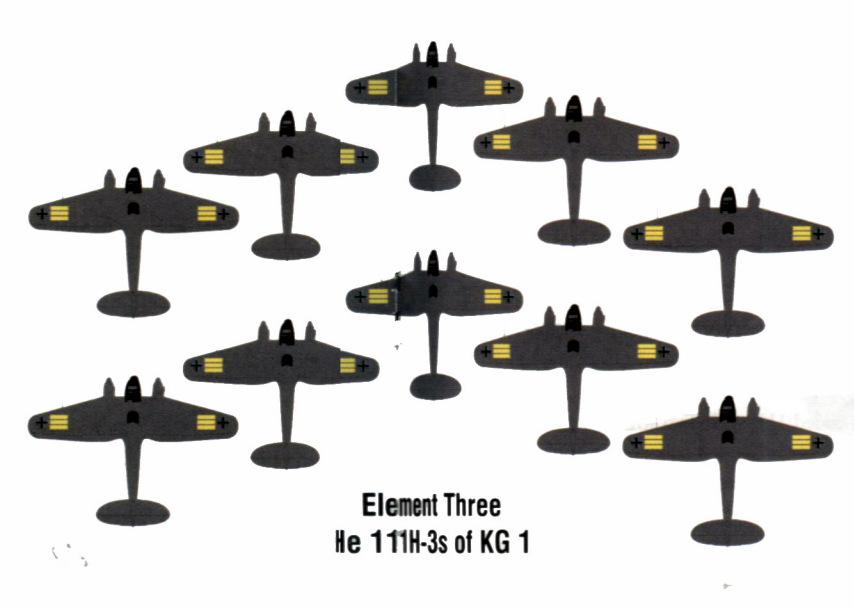
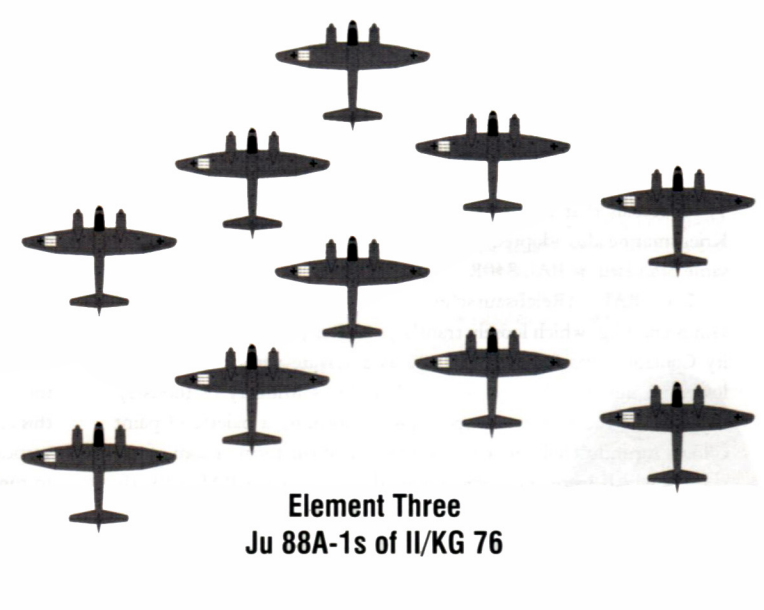
Luftwaffe raid on London, 7 September 1940

This schematic view shows how the bomber formations sent by the Luftwaffe against London during September 1940 may have looked. This, admittedly speculative, illustration, based upon reports of the actual raid on London on 7 September 1940, also illustrates a theory of how the 'mysterious bar markings', applied to so many Luftwaffe bombers during September 1940, may have been used in assisting in the formation keeping of so many aircraft from many different units and bases

A provisional interpretation of how these bar markings might have been applied to a three-Geschwader formation at almost full strength in three columns based on an account of the opening attack on London of 7 September, is illustrated in the accompanying diagram. The formation illustrated is based on a photograph which shows the aircraft in a Staffel formation known to have been used in daylight over the UK towards the end of August, as it has been impossible to find photographic evidence of the twenty aircraft in a double 'V' formation described above.
